Monongahela Dam 4 Spillway, Pennsylvania Hydraulic Model Investigation

by Deborah R. Cooper

Office of Management and Budget, Paperwork Reduction	on Project (0704-0186), Washington, D						
1. AGENCY USE ONLY (Leave blank)	2. REPORT DATE May 1997	3. REPORT TYPE A Final report	AND DATES COVERED

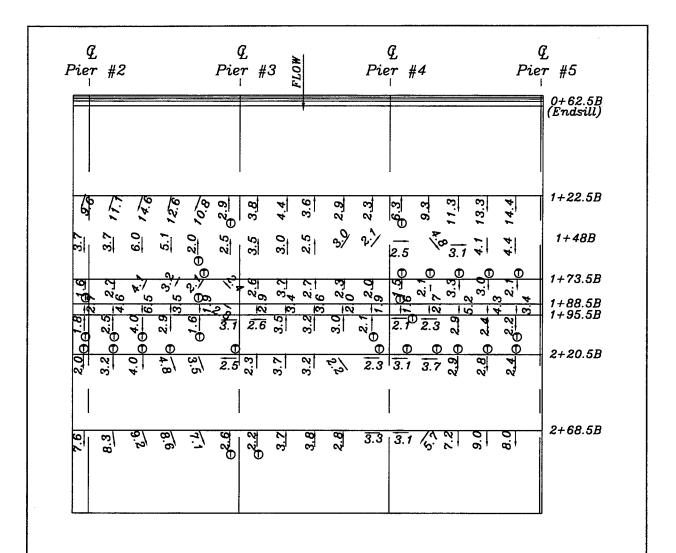
BOTTOM VELOCITIES TYPE 3 RIPRAP/ROCK APRON CONFIGURATION 1 Q = 815 CU M/SEC (29,100 CFS) $G_2 = 3.0 \text{ m} (10 \text{ ft}), G_3 = 0 \text{ ft},$ $G_4 = 2.4 \text{ m } (8 \text{ ft})$ POOL EL 743.5, TW EL 733.1

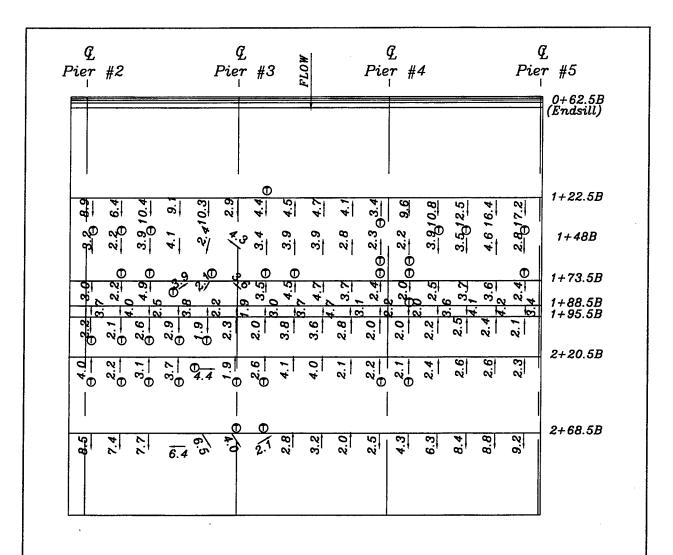
BOTTOM VELOCITIES

TYPE 3 RIPRAP/ROCK APRON CONFIGURATION 1 Q = 1,078 CU M/SEC (38,500 CFS) $G_2 = 3.6 \text{ m } (12\text{ft}), G_3 = 0 \text{ ft}, G_4 = \text{FULL}$ POOL EL 743.5, TW EL 736.3

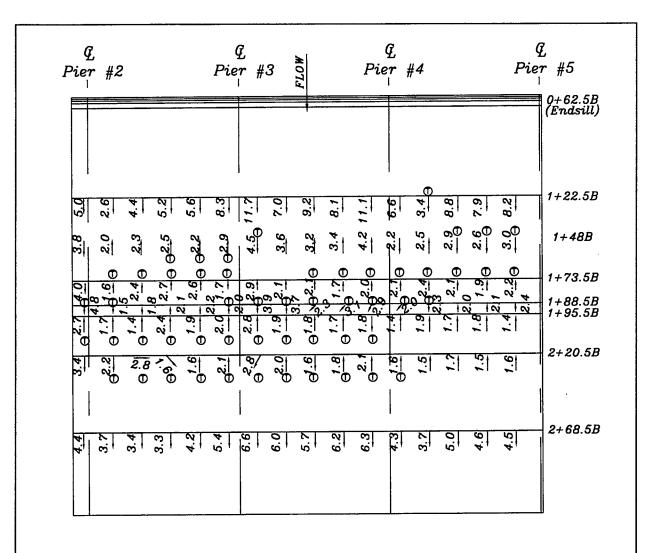
BOTTOM VELOCITIES

TYPE 3 RIPRAP/ROCK APRON CONFIGURATION 1 Q = 1,193 CU M/SEC (42,600 CFS) $G_2 = 2.4$ m (8 ft), $G_3 = 3.0$ m (10 ft), $G_4 = 2.4$ m (8 ft)

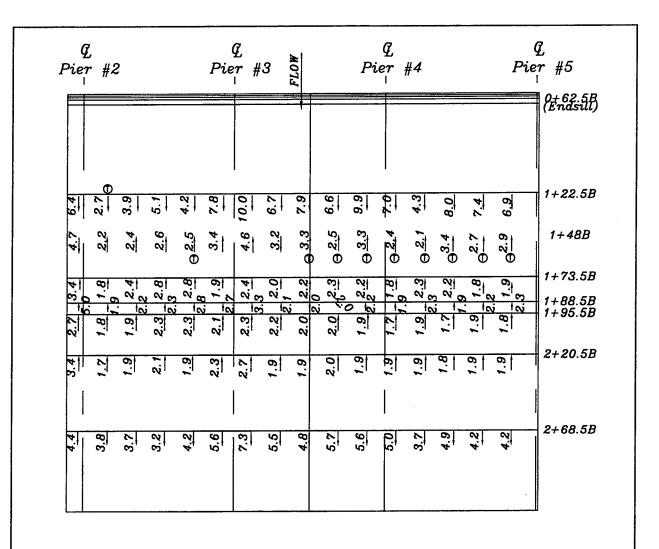
TYPE 3 RIPRAP/ROCK APRON CONFIGURATION 1

Q = 1,366 CU M/SEC (48,800 CFS) $G_2 = 3.0$ m (10 ft), $G_3 = 3.6$ m (12 ft), $G_4 = 3.0$ m (10 ft)

POOL EL 743.5, TW EL 737.1

BOTTOM VELOCITIES

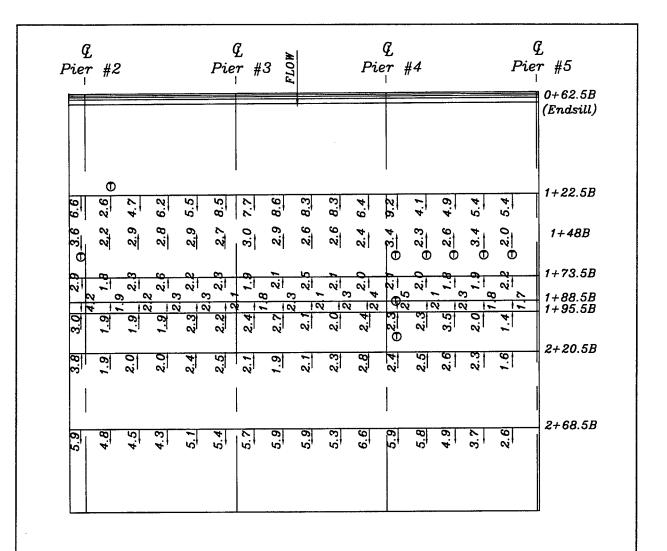
BOTTOM VELOCITIES

TYPE 3 RIPRAP/ROCK APRON CONFIGURATION 1

Q = 1,537 CU M/SEC (54,900 CFS) G_2 = 3.6 m (12 ft), G_3 = FULL, G_4 = 3.6 m (12 ft)

POOL EL 743.5, TW EL 739.0

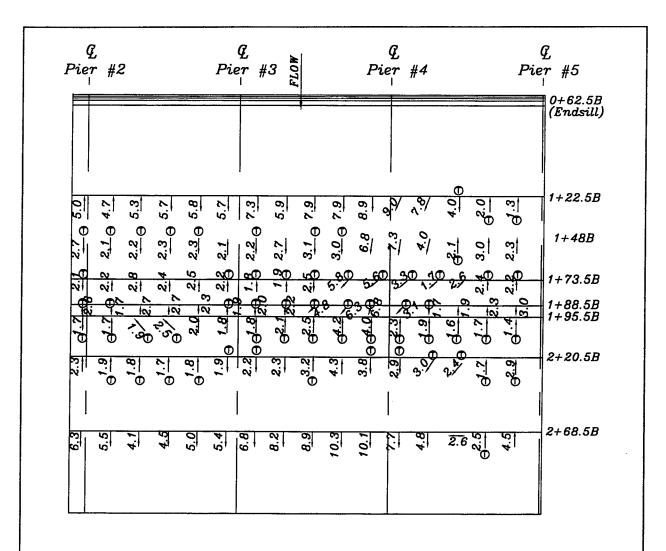
BOTTOM VELOCITIES

TYPE 3 RIPRAP/ROCK APRON

Q = 1,630 CU M/SEC (58,200 CFS)

$G_2 = FULL, G_3 = FULL, G_4 = FULL$ POOL EL 743.5, TW EL 740.3

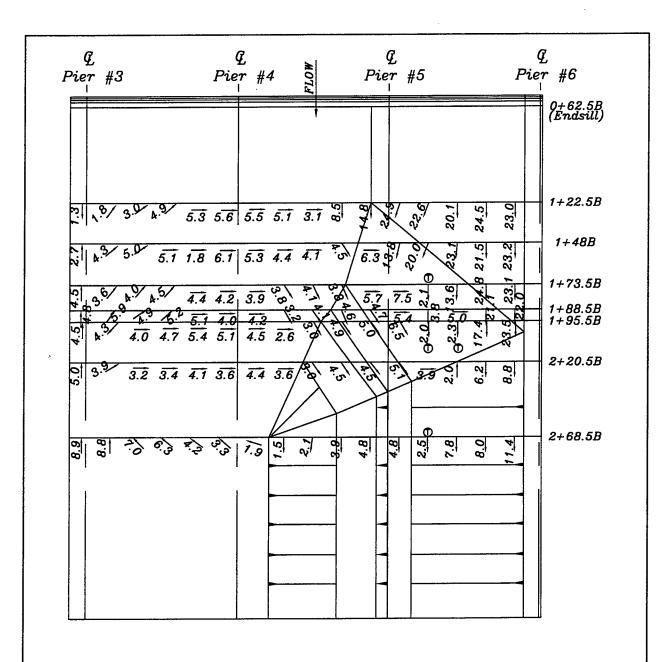
BOTTOM VELOCITIES

TYPE 3 RIPRAP/ROCK APRON CONFIGURATION 2 Q = 314 CU M/SEC (11,200 CFS) G_3 = 0 ft, G_4 = 0 ft, G_5 = 1.8 m (6 ft) POOL EL 743.5, TW EL 723.7

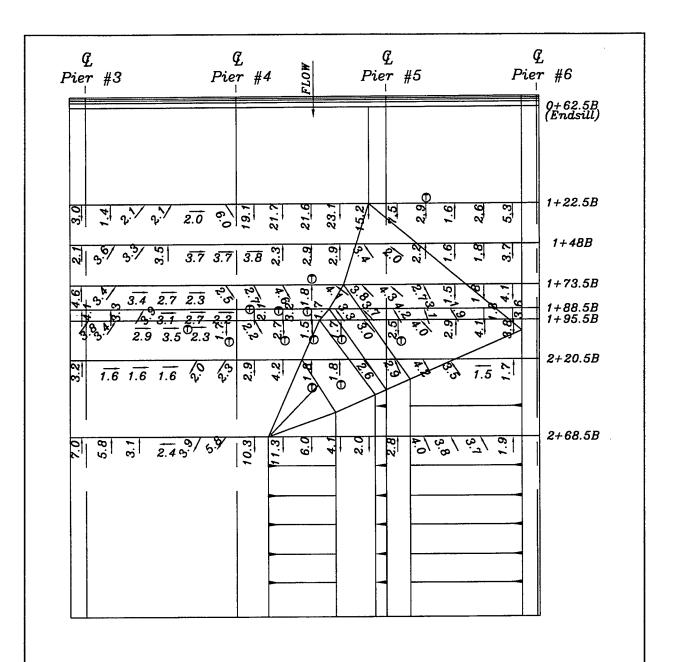
BOTTOM VELOCITIES

Q = 314 CU M/SEC (11,200 CFS) $G_3 = 0$ ft, $G_4 = 1.8$ m (6 ft), $G_5 = 0$ ft POOL EL 743.5, TW EL 723.7

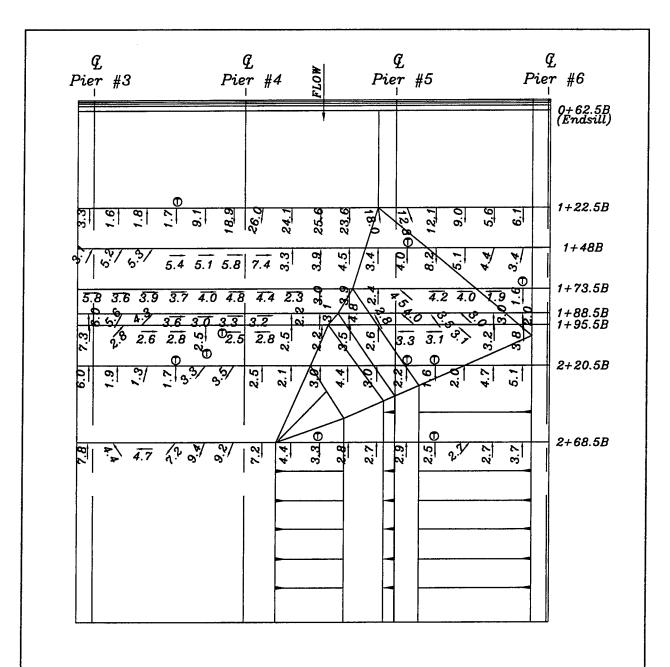
BOTTOM VELOCITIES

TYPE 3 RIPRAP/ROCK APRON CONFIGURATION 2 Q = 378 CU M/SEC (13,500 CFS) $G_3 = 0$ ft, $G_4 = 2.4$ m (8 ft), $G_5 = 0$ ft POOL EL 743.5, TW EL 723.7

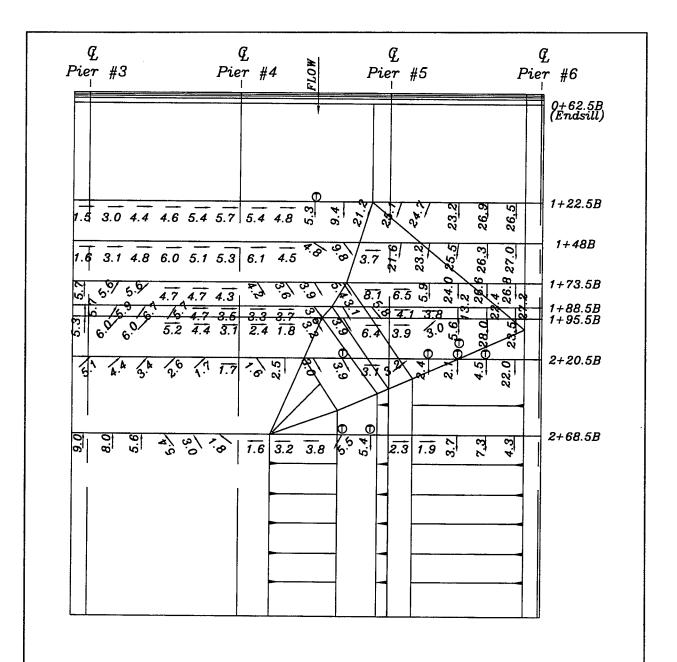
BOTTOM VELOCITIES

TYPE 3 RIPRAP/ROCK APRON CONFIGURATION 2 Q = 378 CU M/SEC (13,500 CFS) $G_3 = 0$ ft, $G_4 = 0$ ft, $G_5 = 2.4$ m (8 ft) POOL EL 743.5, TW EL 723.7

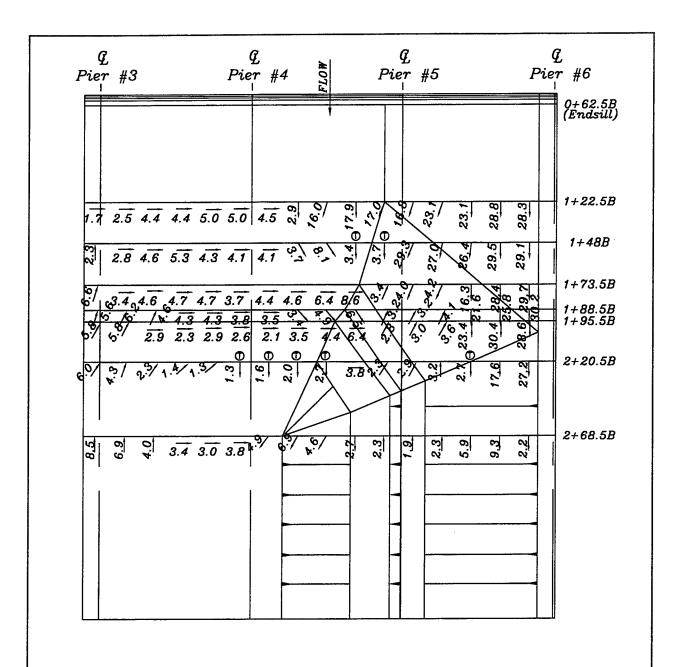
BOTTOM VELOCITIES

TYPE 3 RIPRAP/ROCK APRON CONFIGURATION 2 Q = 437 CU M/SEC (15,600 CFS) $G_3 = 0 \text{ ft, } G_4 = 0 \text{ ft, } G_5 = 3.0 \text{ m (10 ft)}$ POOL EL 743.5, TW EL 723.7

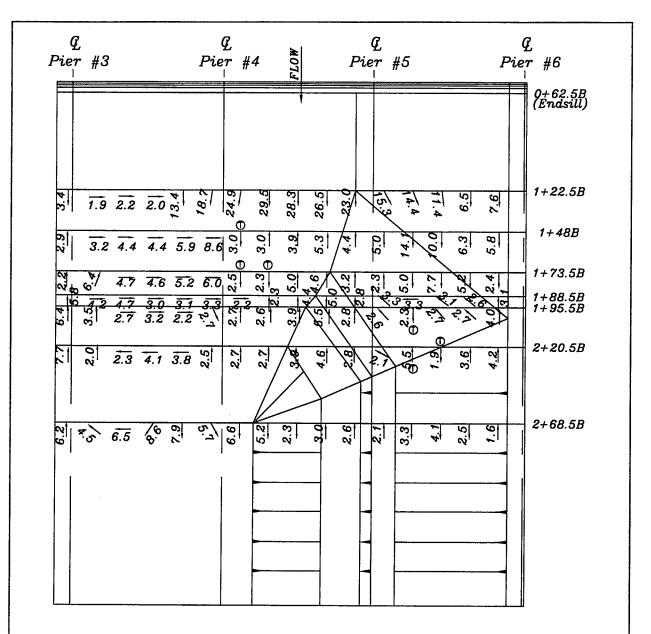
BOTTOM VELOCITIES

TYPE 3 RIPRAP/ROCK APRON CONFIGURATION 2 Q = 437 CU M/SEC (15,600 CFS) G_3 = 0 ft, G_4 = 3.0 m (10 ft), G_5 = 0 ft POOL EL 743.5, TW EL 723.7

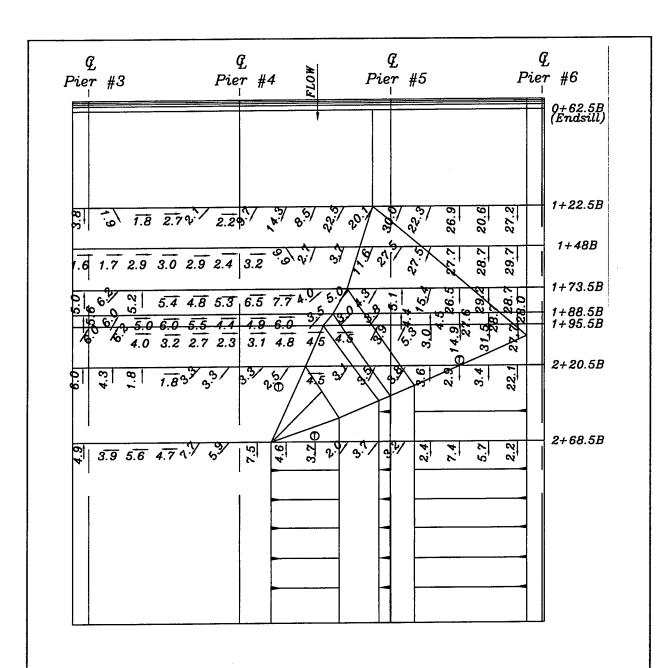
BOTTOM VELOCITIES

Q = 574 CU M/SEC (20,500 CFS) $G_3 = 0$ ft, $G_4 = 0$ ft, $G_5 = FULL$ POOL EL 743.5, TW EL 723.7

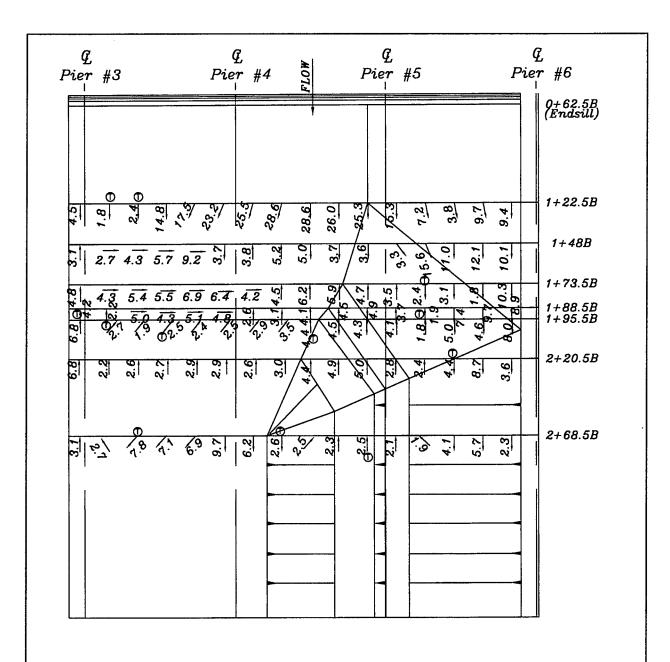
BOTTOM VELOCITIES

TYPE 3 RIPRAP/ROCK APRON CONFIGURATION 2 Q = 574 CU M/SEC (20,500 CFS) $G_3 = 0$ ft, $G_4 = FULL$, $G_5 = 0$ ft POOL EL 743.5, TW EL 723.7

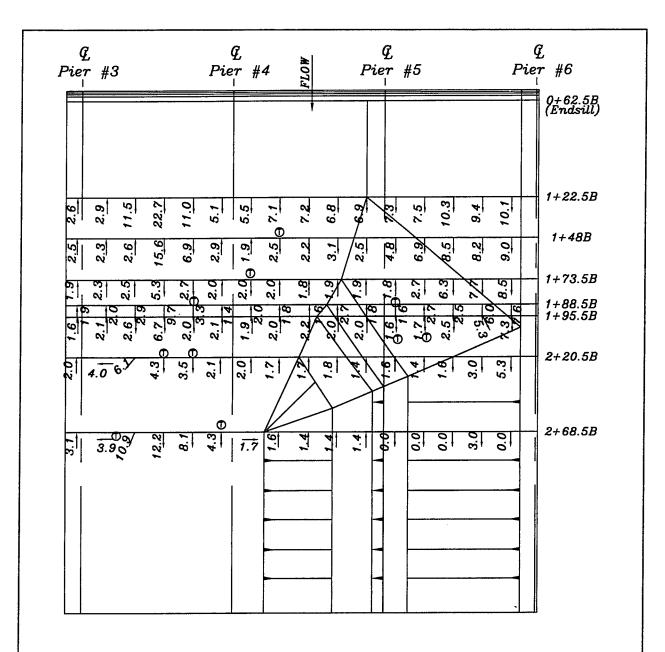
BOTTOM VELOCITIES

TYPE 3 RIPRAP/ROCK APRON CONFIGURATION 2 Q = 762 CU M/SEC (27,200 CFS) $G_3 = 1.8 \text{ m } (6 \text{ ft}), G_4 = 1.2 \text{ m } (4 \text{ ft}),$ $G_5 = 1.2 \text{ m} (4 \text{ ft})$ POOL EL 743.5, TW EL 730.6

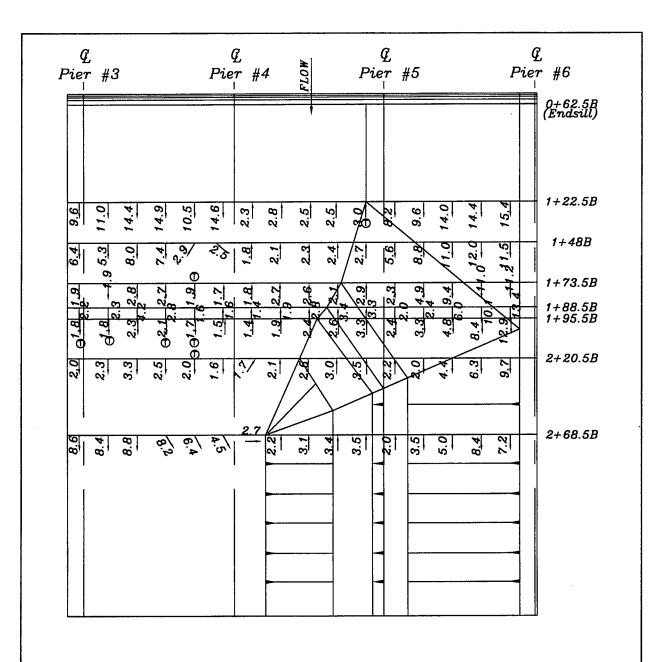
BOTTOM VELOCITIES

TYPE 3 RIPRAP/ROCK APRON
CONFIGURATION 2
Q = 815 CU M/SEC (29,100 CFS) $G_3 = 3.0 \text{ m (10 ft)}, G_4 = 0 \text{ ft},$ $G_5 = 2.4 \text{ m (8 ft)}$ POOL EL 743.5, TW EL 733.1

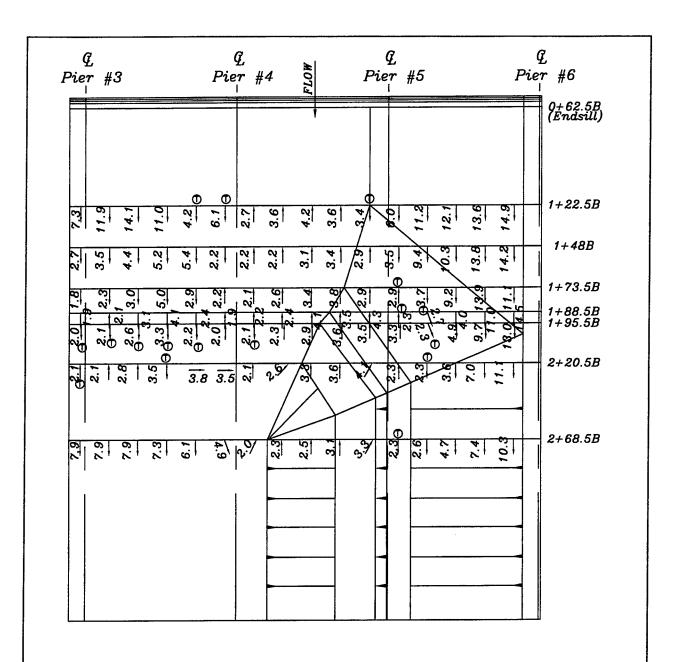
BOTTOM VELOCITIES

TYPE 3 RIPRAP/ROCK APRON CONFIGURATION 2 Q = 1,078 CU M/SEC (38,500 CFS) $G_3 = FULL, G_4 = 0$ ft, $G_5 = 3.6$ m (12 ft) POOL EL 743.5, TW EL 736.3

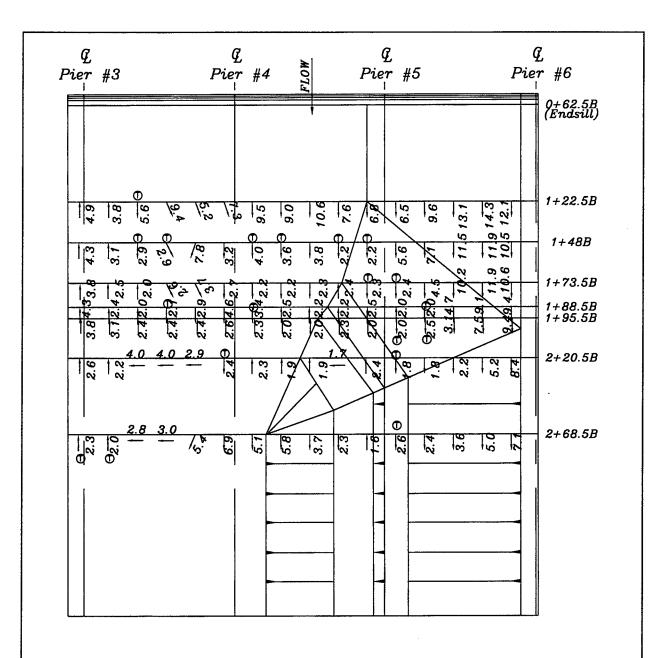
BOTTOM VELOCITIES

TYPE 3 RIPRAP/ROCK APRON CONFIGURATION 2 Q = 1,193 CU M/SEC (42,600 CFS) $G_3 = 3.0$ m (10 ft), $G_4 = 2.4$ m (8 ft), $G_5 = 2.4$ m (8 ft) POOL EL 743.5, TW EL 735.5

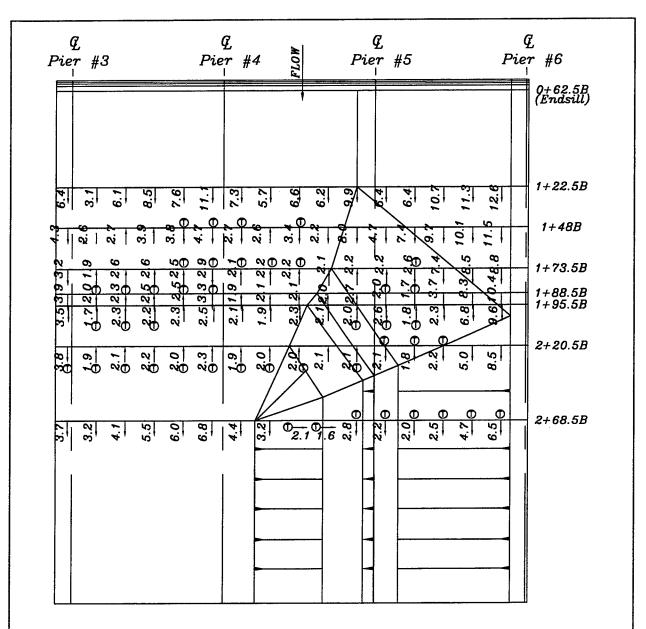
BOTTOM VELOCITIES

TYPE 3 RIPRAP/ROCK APRON CONFIGURATION 2 Q = 1,366 CU M/SEC (48,800 CFS) $G_3 = 3.6 \text{ m} (12 \text{ ft}), G_4 = 3.0 \text{ m} (10 \text{ ft}), G_5 = 3.0 \text{ m} (10 \text{ ft})$ POOL EL 743.5, TW EL 737.1

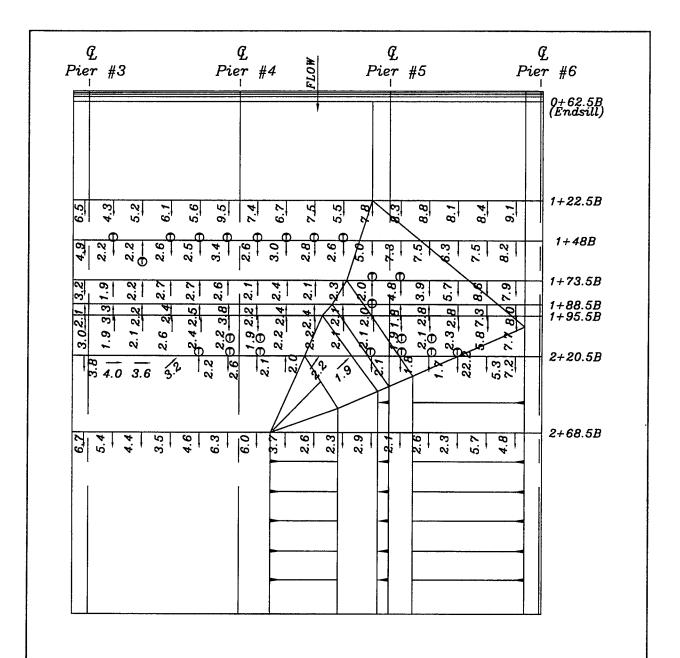
BOTTOM VELOCITIES

TYPE 3 RIPRAP/ROCK APRON CONFIGURATION 2 Q = 1,537 CU M/SEC (54,900 CFS) $G_3 = FULL$, $G_4 = 3.6$ m (12 ft), $G_5 = 3.6 \text{ m} (12 \text{ ft})$ POOL EL 743.5, TW EL 739.0

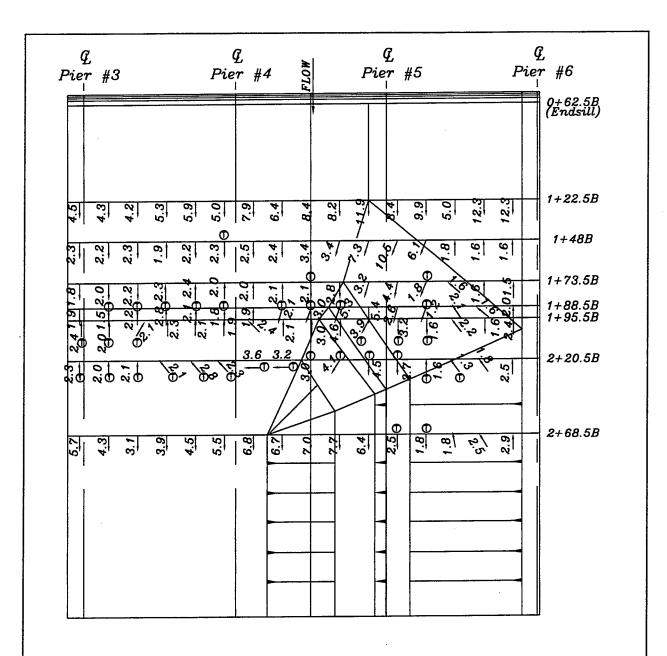
BOTTOM VELOCITIES

TYPE 3 RIPRAP/ROCK APRON
CONFIGURATION 2

Q = 1,630 CU M/SEC (58,200 CFS) $G_3 = FULL$, $G_4 = FULL$, $G_5 = FULL$ POOL EL 743.5, TW EL 740.3

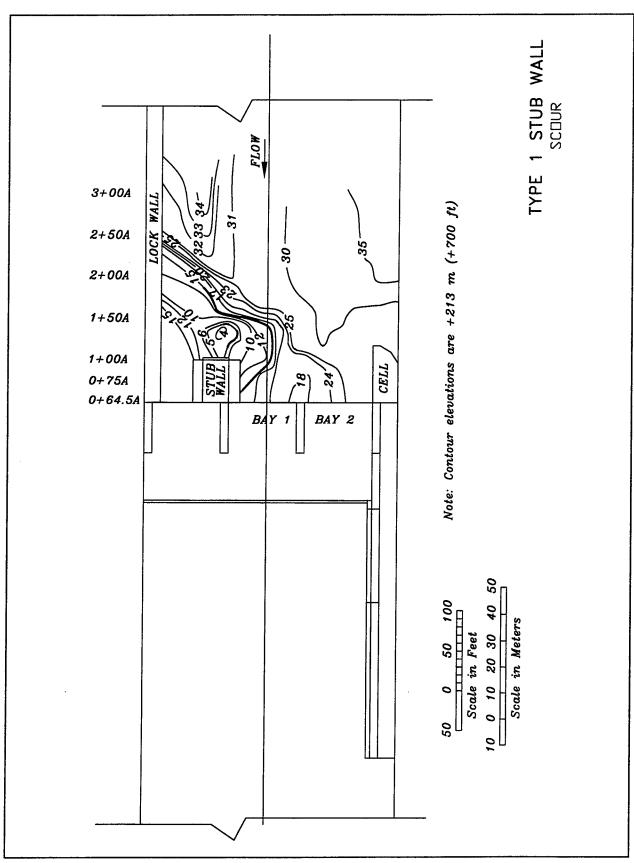
Plate 52 and shown in Figure 8. Scour depths to el 704 were recorded in the immediate vicinity of the stub wall and to el 718 near the dam face.

A 17.7-m- (58-ft-) wide and 17.1-m- (56-ft-) long stub wall was simulated in the model upstream of the dam along the lock wall as shown in Plate 51 and Figure 7. The Pittsburgh District engineers requested experiments to analyze the scour caused by the stub wall in the prototype. Each of the steady-state conditions in the tabulation on page A12 was run to simulate discrete discharges for a hydrograph provided by the Pittsburgh District. Soundings were measured in the model, and the resulting scour contours were plotted in

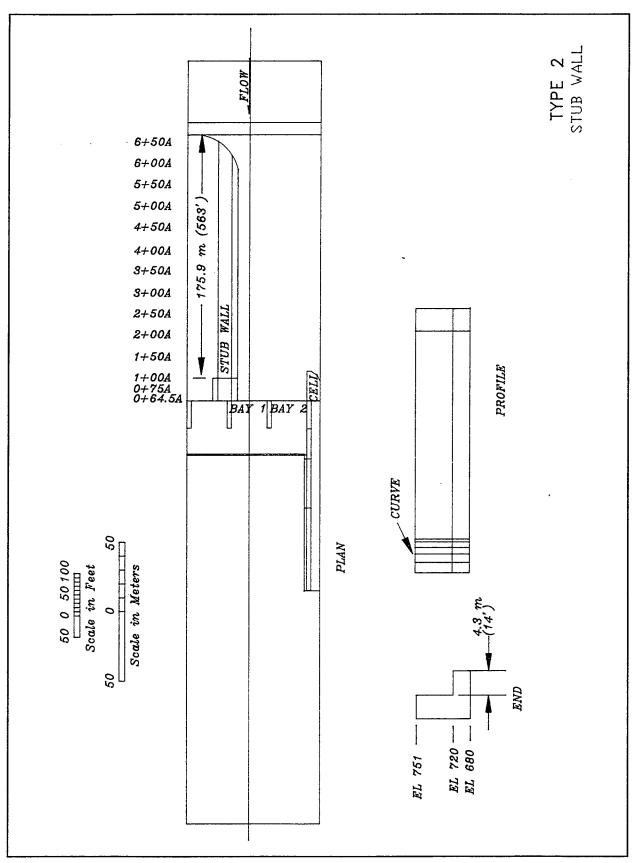
Plate 53

The stub wall was extended 171.6 m (563 ft) upstream (Plate 53) to simulate future proposed conditions with the new lock that might alleviate the potential for severe scour near the upstream face of the dam. Each of the steady-state conditions in the tabulation on page A12 for proposed conditions was run to simulate discrete discharges from a hydrograph provided by the Pittsburgh District. Soundings were measured in the model, and resulting scour contours were plotted in Plate 54. Extending the stub wall 171.6 (563 ft) decreased the potential for severe scour immediately upstream of the dam. Scour depths to el 720 were recorded near the upstream face of the dam.

Experiments to analyze the scour caused by a 17.7-m- (58-ft-) wide and 17.1-m- (56-ft-) long stub wall upstream of the dam along the lock wall indicated severe scour potential near the stub wall and the dam face. Extending the stub wall upstream 171.6 m (563 ft) in the model decreased the scour potential markedly.
